Massachusetts Historical Commission Massachusetts Archives Building

Address 31 Lincoln Street

Historic Name Alice Simonds House

## BUILDING FORM (31 Lincoln Street)

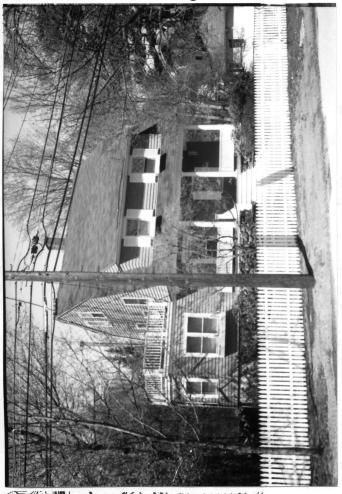
The house at 31 Lincoln Street is a 1 3/4-story, wood shingled residence which rests on a stone foundation. Set with its broad side to the street the house is capped by a gambrel roof, now sheathed in asphalt shingles. Along the length of the front facade, the overhang of the roof provides shelter for a recessed porch which is supported by four Roman Doric columns. Wooden steps front the central two columns; on the adjacent sides the columns are spanned by simple stick balusters. The sidehall entrance retains its glass and raised panel door which also displays a dentil course under the window. Immediately adjacent to the door jamb is an elevated, diamond-paned window. Remaining windows on the house, including the other window sheltered by the front porch, are 1/1 doublehung units with diamond panes in the upper sash. The shed dormer spanning the front roof slope is punctuated by two smaller windows of the same configuration. On the east side, there is a three-sided, single-story bay window set above a stone foundation.

The west side elevation of the house is spanned by a single-story, flat-roofed addition set above a concrete foundation with a three-sided west wall. The addition is capped by a stick balustrade with square posts. The windows contain 1/1 sash. A wooden deck is located at the rear of the house.

A driveway extends along the east side of the house, terminating at a single-car, wood-shingled garage which is capped by a hip roof. There is an overhead garage door facing the street and two 6/6 windows on the side. Along the front lot line there is a wooden picket fence.
